**ROLLING CONTACT FATIGUE IN RAILS;**

**A GUIDE TO CURRENT UNDERSTANDING**

**AND PRACTICE**

RT/PWG/001

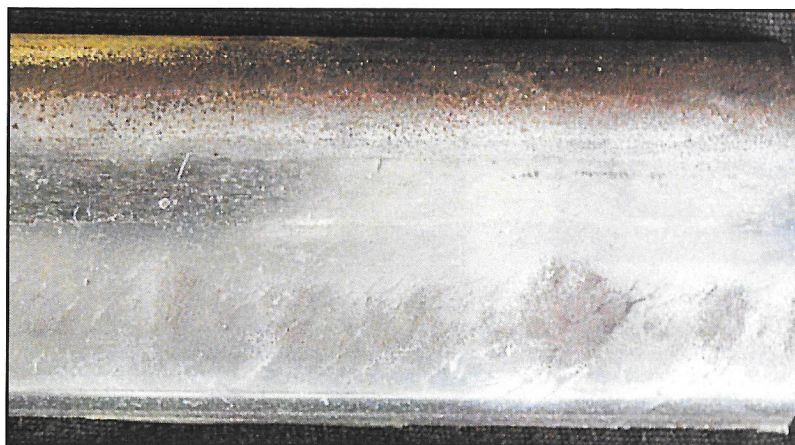
It is actually very difficult to see (or feel) head checking in the earliest stages of development because the cracks are small and fine. At a later stage, like squats, they are often spotted because of shadows emerging from slight surface depressions.

*Head Check Cracks with "Shadows"*

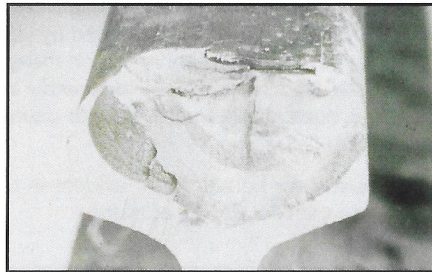
*Surface & Fracture Face Appearance of Squat Type Defects*

Distinctive features are the dark shadowy area within the running band and an associated widening of the running band. The shadow results from the crack growing on a nearly horizontal plane just below the running surface. This means that the running surface over the crack is detached from the rest of the rail and as a result can flow sideways under wheel loading more easily - hence the widening of the running band. As the metal flows out sideways however, a slight dip develops over the crack allowing corrosion products and dirt to accumulate, resulting in the 'shadow'.

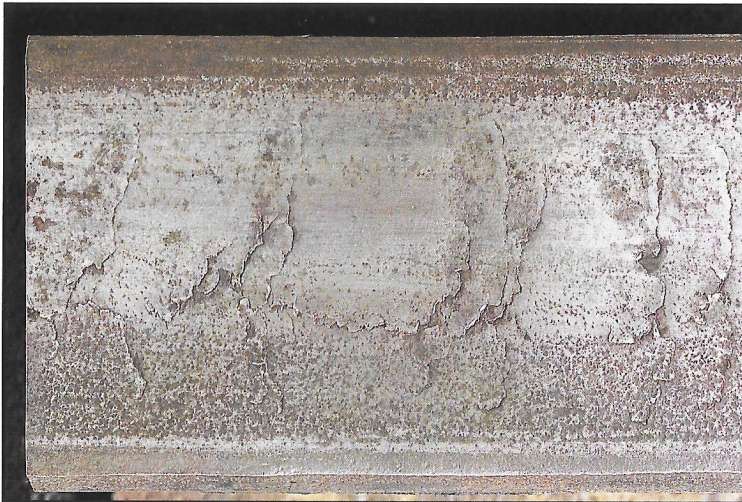
False flange damage appears as a crushed zone on the rail head on the stock rails of S&C and also on the wing and nose of crossings. On a stock rail the zone starts at the outside of the rail and gradually migrates across to the four foot side. Where the problem has been present for a long time, virtually the whole of the rail head may be worn concave at the centre of the affected region. Cracking may develop both longitudinally and transverse to the rail head.

*False Flange Damage*

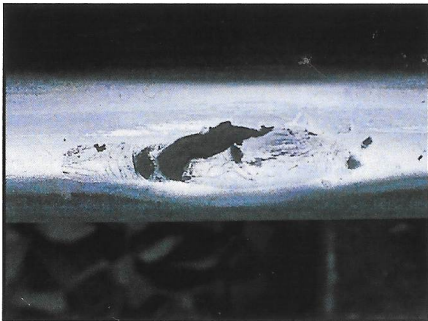
The martensite is also very brittle with the result that it tends to spall off very easily (see the photograph of an isolated wheelburn on the left). This also results in the rail being locally untestable and again the site should be categorised as 'Severe'. Additionally, the railhead surface irregularity will significantly increase dynamic impact forces and the likelihood of rail breakage will be raised.

*Wheelburn*

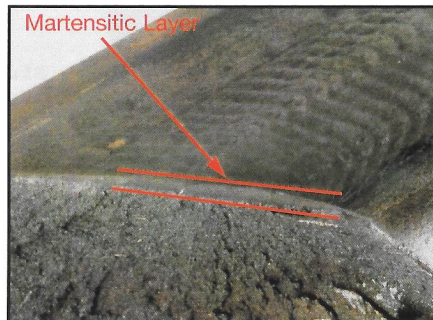
*Wheelburn - Martensite Layer*

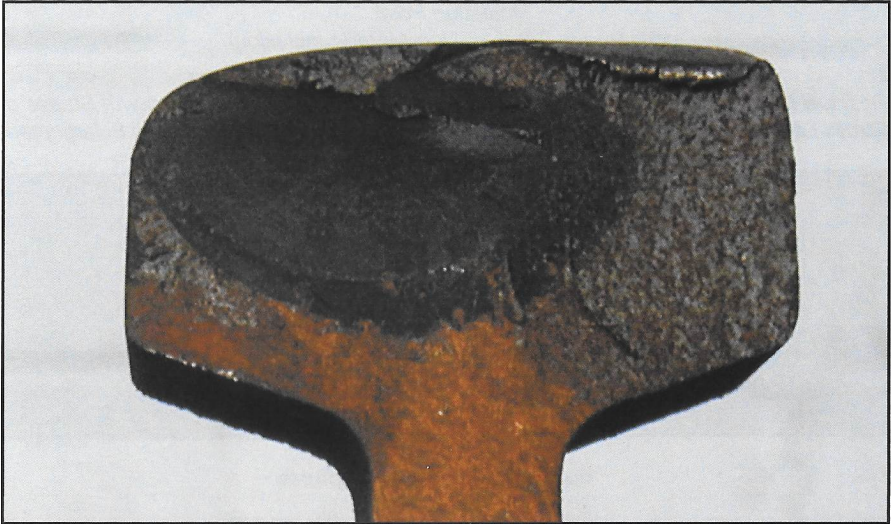
*Broken Rail From a Head Check Defect (Originating from Gauge Corner)*

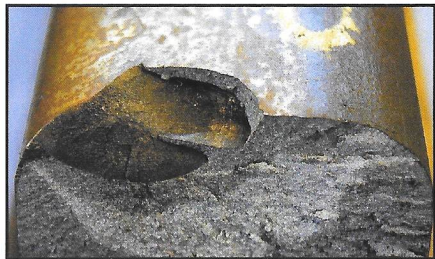
*This Shows the Two Stage Development of a Crack from a Head Check.*

*(This rail was removed as defective and broken open in a laboratory).*

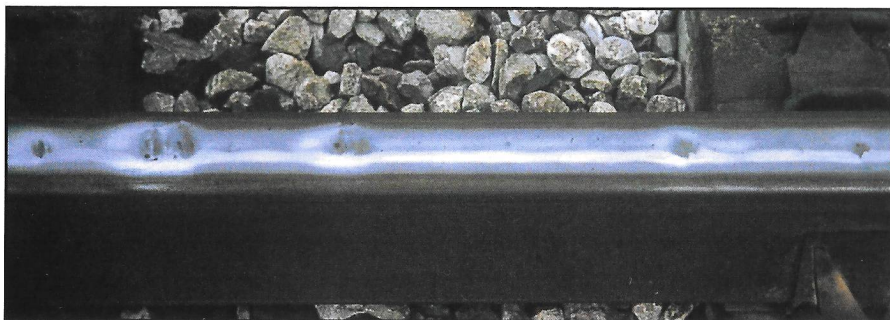
*Multiple Squats*
