## MANAGEMENT OF CYCLIC TOP

Produced by Civil Engineering Conference  
For use by all Railway Civil Engineering Staff

CEC/DG/002  
Issue 2  
September 2002

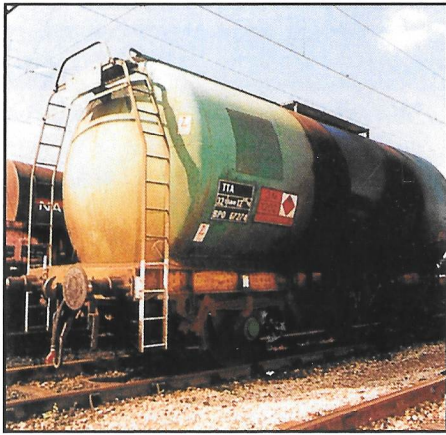
*Photograph - An IVA Wagon*

These types of vehicles are susceptible to derailment caused by cyclic top.

This bouncing frequency is particularly severe in some types of freight wagon which have susceptible suspension. These include IVA and TTA as shown in the photographs below. The possibility of a permanent ban or permanent speed restriction on this stock has been rejected because of the number of such wagons and because many of them are from continental Europe.

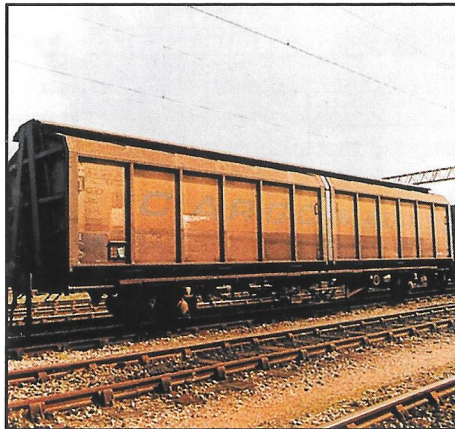
*Photograph - A TTA Wagon*

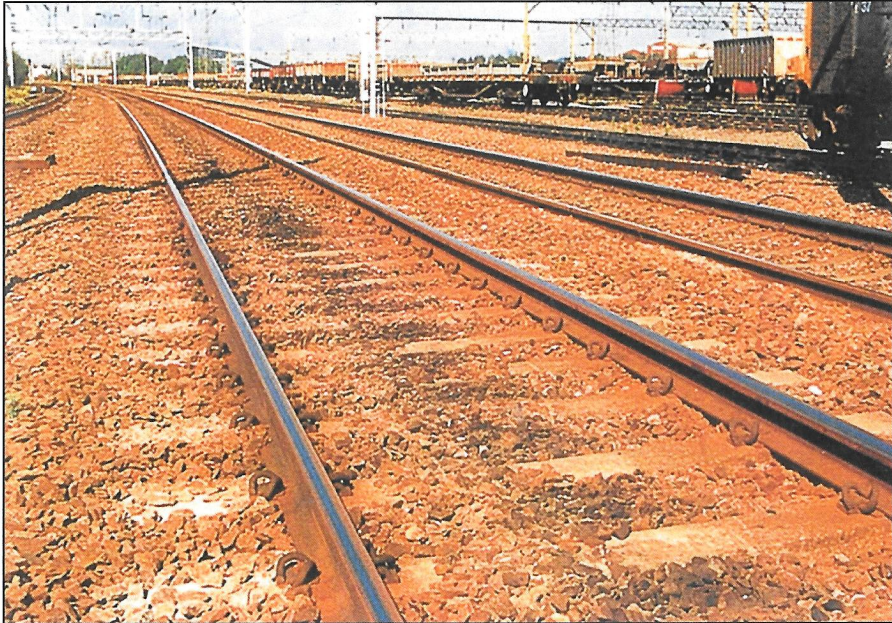
*Photograph - Lighter coloured ballast on the sleeper ends indicates voiding.*

A clue to look out for is any evidence of voiding. This may be observed under a passing train or by the presence of lighter coloured ballast next to the voided sleeper.
