**HOT WEATHER**

**GUIDELINES FOR**

**PERMANENT WAY**

CEC/DG/007  
Issue 1  
January 2001

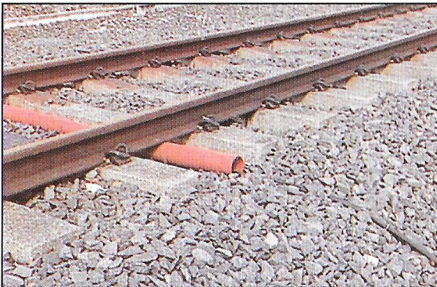
*The sleeper ends are exposed, so there is inadequate horizontal shoulder ballast, nor is it piled 125mm high.*

If there is inadequate ballast to resist the lateral forces then the track will obviously move bodily when excessive compressive forces occur in the rails.

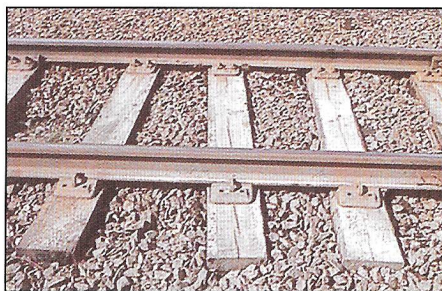
*The white dust on top of the sleepers suggests that there is a problem with the material in the ballast beneath.*

If the ballast under the sleepers is wet or fouled with a soft material such as marl or clay, this will again seriously reduce the friction.

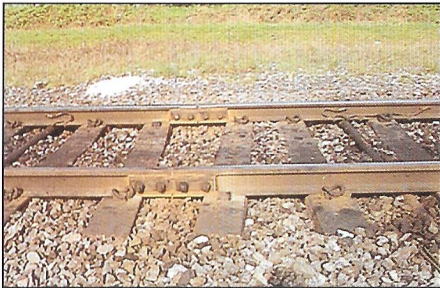
*The sleepers are out of square, fastenings are missing and the insulated joint, appears to be breaking up.*

Poorly spaced sleepers may provide inadequate or variable resistance, out of square sleepers will cause tight gauge which in turn will give high lateral forces from passing wheels.

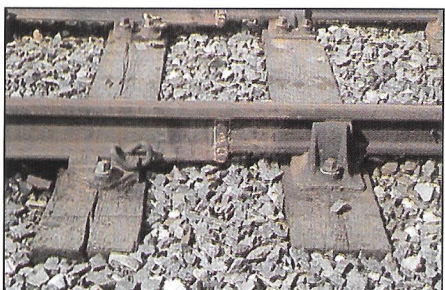
*A composite weld at the change from flat bottom to bullhead rail.*

Where BH abuts FB track or concrete sleepers abut wood, or different types of sleepers of the same material, then there is a difference in weights and a variation in friction.

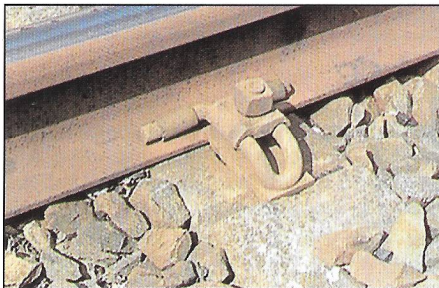
*A maintenance screw has been fitted to this BJB fastening, but the gauge plate is on top of the rail foot, so the gauge is suspect.*

- iii) Mills. The clips often become loose in the housing through wear and rusting. A nylon toe shoe for insertion under the top of the clip has been designed but does not appear to be in common use.
- iv) BJB, RN, NABLA. These have now become a serious maintenance problem in many places. The beechwood insert in the concrete has rotted away and the coach screw has little if any hold and the whole fastening becomes loose, this seriously reduces if not totally eliminates the toe load and can cause significant gauge variation. Pandrol housings can be glued in to replace the original BJB screw.
- v) There may be other types of fastenings (e.g. RNB) in existing CWR which are not now used where similar problems occur resulting in loss of toe load or lateral restraint.

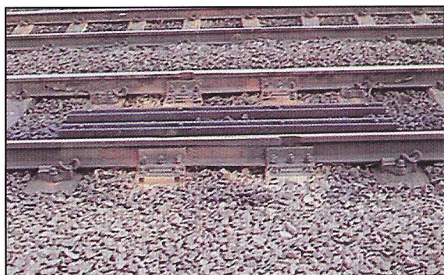
*Some voiding of this adjustment switch is apparent from the white dust on the sleepers and baseplates.*

The clamps and the overlapping rails should be kept lightly oiled to permit thermal movement at any time of the year. The screws fastening the baseplates to the timbers must be kept tight. Where plastic "cheeses" are present these must be watched for wear, especially in the bolt pockets with T bolt fastenings.

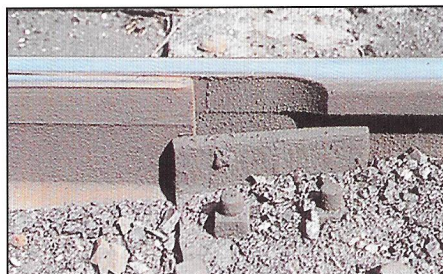
*Both these adjustment switches require urgent attention.*

If there are straps in the four foot they must be screwed down 'tightly to stabilise the adjustment switch timbers.

Settings must be checked on a regular basis, and action taken where gaps become too wide (especially in summer) or too tight (especially in winter). Where resetting is required regularly, the underlying causes should be investigated. This may be indications of rail movement in the CWR indicating a potential loss of stress, or in jointed track indicators of rail creep.

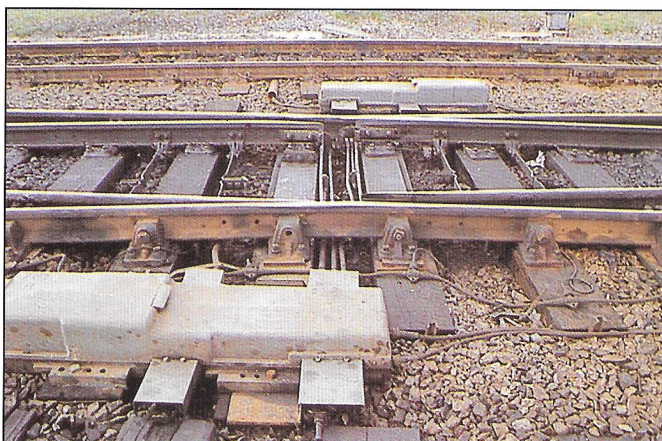
*The dimensions for the switch toes can be found in RT/CE/S/104 Track Maintenance Requirements.*

- a) Check that all bolts (stock rail, heel block, stress transfer, insulated, tight and normal ones) are in place and have been correctly torqued tightened.
- b) Ensure that following any replacement of switches or crossings, correct restressing has been carried out into the adjacent CWR, where applicable.
- c) Ensure that switch toe dimensions are correct, especially in switch diamonds. This is particularly important if the switches are of rolled manganese, which has a coefficient of expansion 50% greater than normal grade steel.
