## **LONGITUDINAL TIMBERS**

### **CIVIL ENGINEERING**

Produced by Civil Engineering Conference  
For use by all railway civil engineering staff

Issue 1  
April 2001

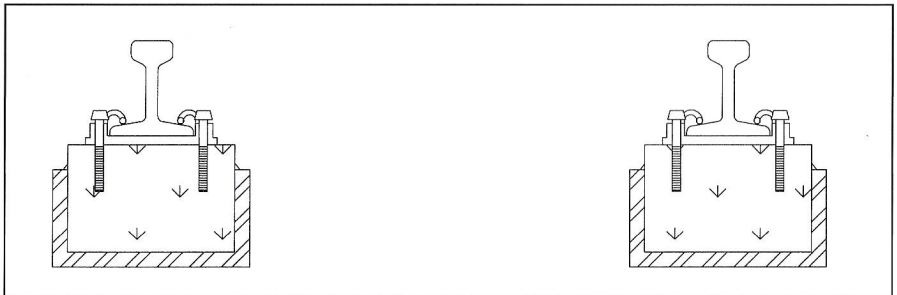
Figure 1

- Timbers in metal troughs (fig 1)
- Longitudinal timbers on rail bearers (fig 2)
- Cross-beams on timber/rail bearers (fig 3)

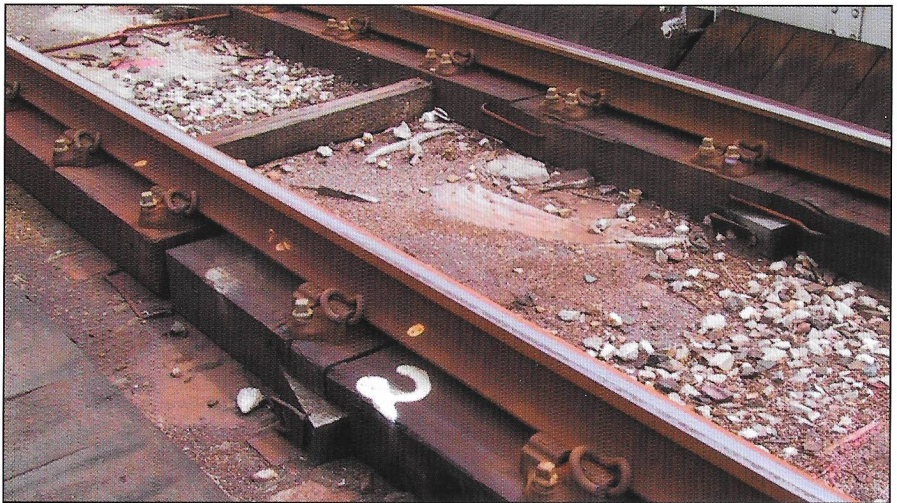
Figure 6 Although there is no laid down minimum length for a longitudinal timber they should be as long as the track design allows. Short timber lengths are bad practice which should be avoided.

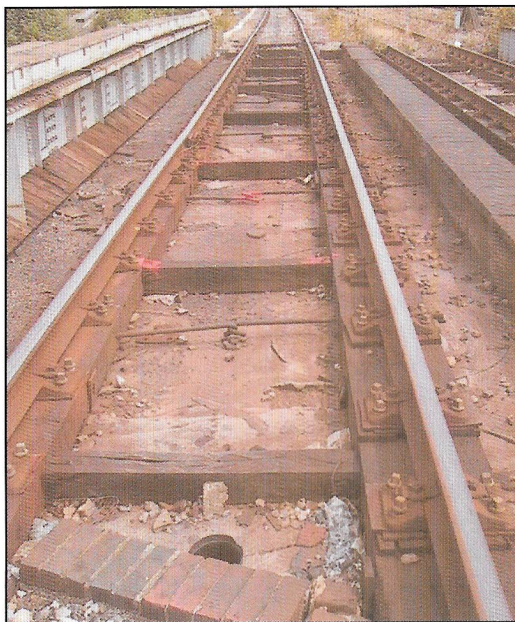
Figure 7 A typical longitudinal timber bridge. Once again the packings used do not cover the baseplate foot print area, note also how close the screw hole centres are to the edge of the timbers.
