## MANAGEMENT OF CYCLIC TOP

Produced by Civil Engineering Conference  
For use by all Railway Civil Engineering Staff

CEC/DG/002  
Issue 2  
September 2002

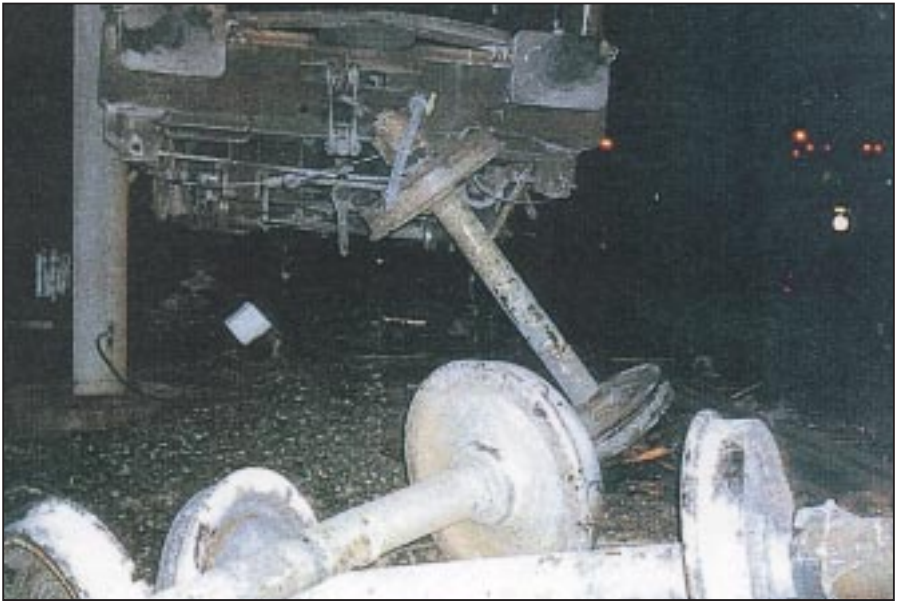
*Photograph - The result of a cyclic top derailment.*

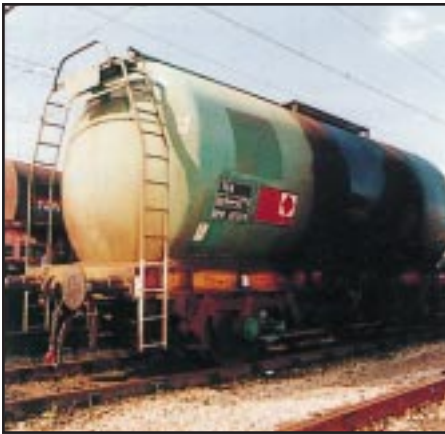
*Photograph - An IVA Wagon*

These types of vehicles are susceptible to derailment caused by cyclic top.

This bouncing frequency is particularly severe in some types of freight wagon which have susceptible suspension. These include IVA and TTA as shown in the photographs below. The possibility of a permanent ban or permanent speed restriction on this stock has been rejected because of the number of such wagons and because many of them are from continental Europe.

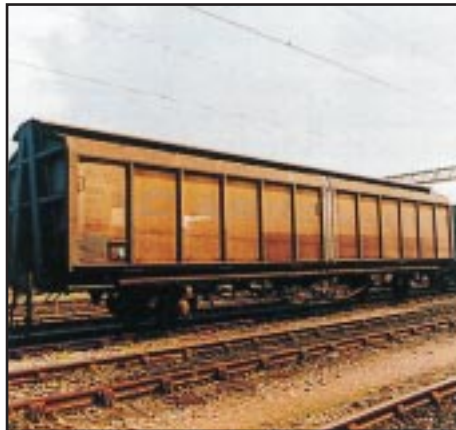
*Photograph - A TTA Wagon*

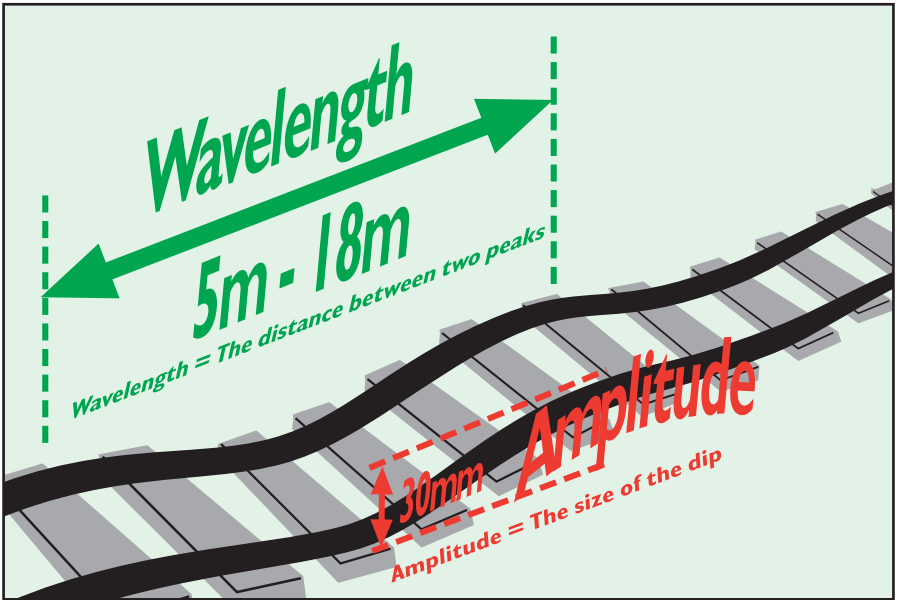
Wavelength and amplitude of cyclic top faults

A particular problem has been shown to occur when the dips are at intervals (wavelength) of between 5 and 18 metres (7 to 28 sleepers). To pose a serious risk of derailment two or more evenly spaced dips (amplitude) are thought to be required. For this reason jointed track is very susceptible to cyclic top faults. The dips may not be immediately obvious because of voiding under sleepers. Train speed is also a factor. It is unlikely that cyclic top derailments will occur at 30mph or less. Fortunately nearly all track with a speed higher than 30mph is track recorded and the location and magnitude of cyclic top identified.

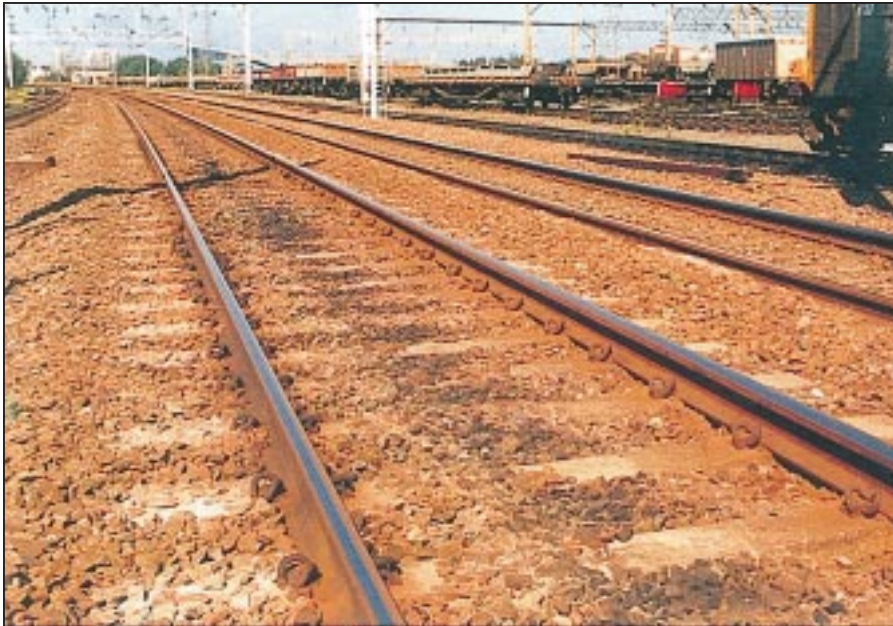
*Photograph - Lighter coloured ballast on the sleeper ends indicates voiding.*

A clue to look out for is any evidence of voiding. This may be observed under a passing train or by the presence of lighter coloured ballast next to the voided sleeper.
