**CREEP IN JOINTED**

**TRACK**

**CIVIL ENGINEERING**

Produced by Civil Engineering Conference  
For use by all railway civil engineering staff

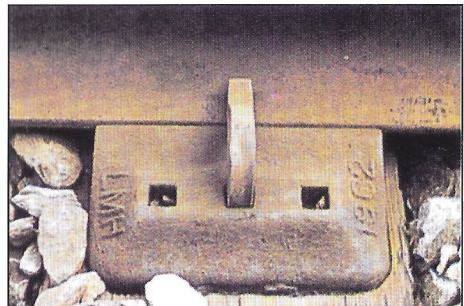
The marks on the top of the rail foot, to the left of the spike and to the right of the baseplate indicate that the rail has been pulled back at least twice.

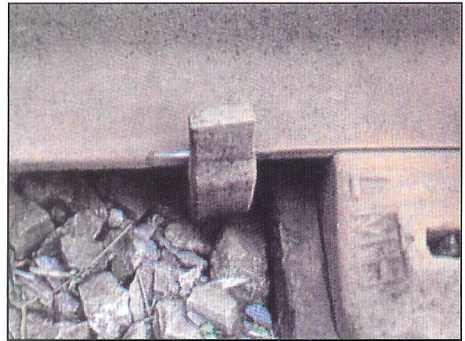
A useless anchor, which has been rattling for some considerable time.

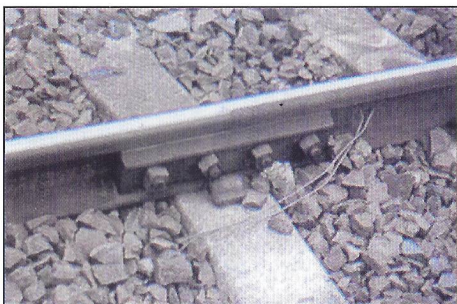
A joint on top of the sleeper. When was it last lubricated or pulled back?

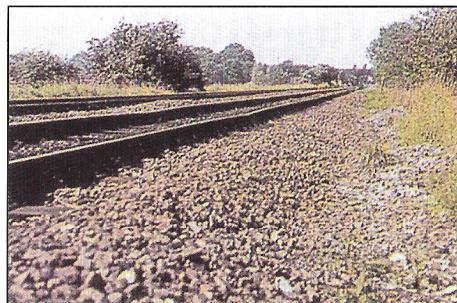
Dipped joints such as this will cause the rails to be driven forward.

**U**ndertake shimming for minor dipped joints, rail end straightening will be necessary for severe dipping.

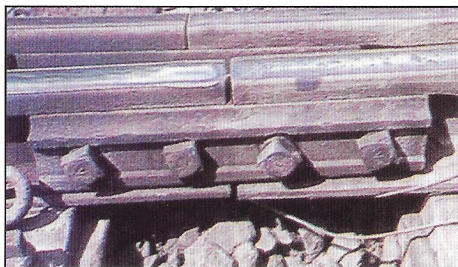
The heel joint at a cast AMS crossing. No TJ plates and a mixture of bolts, permitting the plain rails to move.

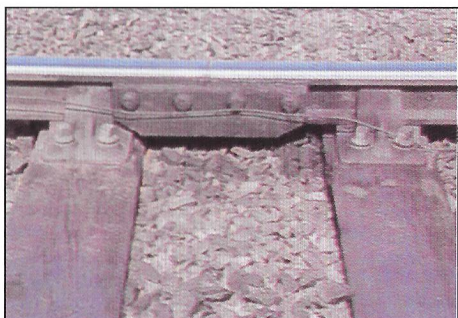
This BH fishplate has been driven hard against the chair by the creep.

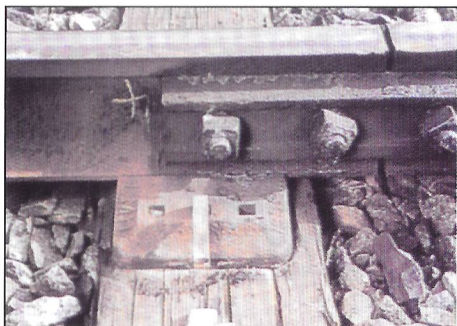
This fishplate has crept so much that the elastic spike has been reversed and only holds the baseplate in position. The baseplate is shuffling badly. The vee gap at the rail foot suggests that a sett has been used to adjust the rails.

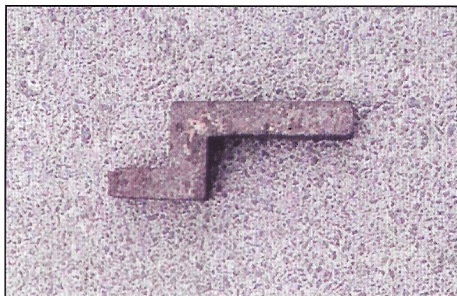
**E**xpansion bits corresponding to the 3, 6 and 10mm gaps can easily be made from pieces of steel of appropriate thickness and are helpful when used with the hydraulic adjuster.

Where a gap is wide the appropriate expansion bit is dropped in, the rails can be closed up by the adjuster onto the bit, the rail fastened down and the bit knocked out. If a number of gaps have bits placed in them then one position of the adjuster can be sufficient to correct all of them at the same time.

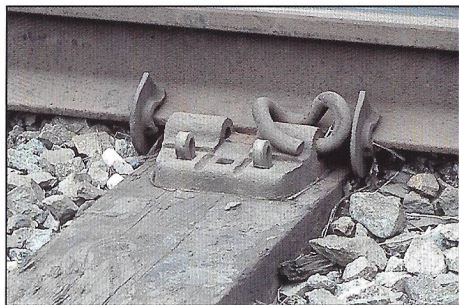
Fair T. Drive with firm blow so that Notch engages opposite edge of Flange

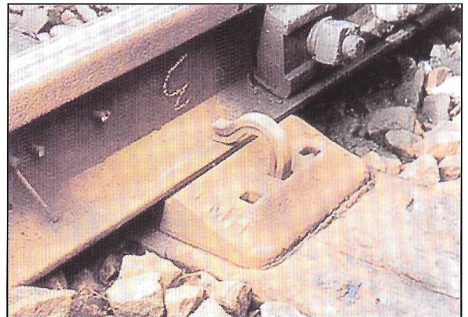
This spike is ineffective; the rail is not tight in the baseplate and the baseplate is shuffling.

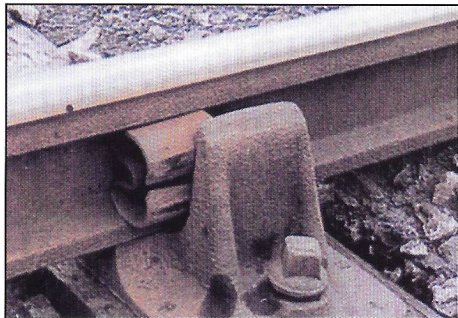
This steel key does not fit correctly. The ballast is very dirty.

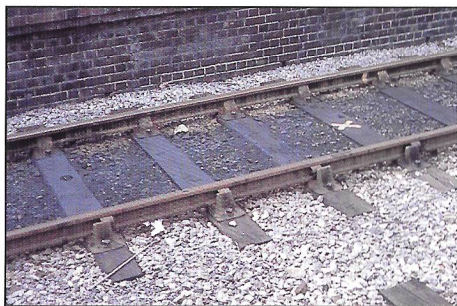
Keys correctly driven in alternative directions

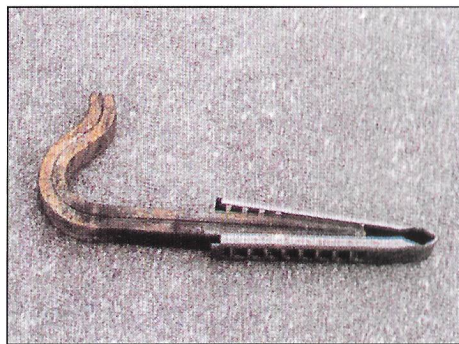
Only AL1 spikes can be fitted in conjunction with spikelocks. If AL23s are used the spikelock will be driven right through the base of the sleeper.

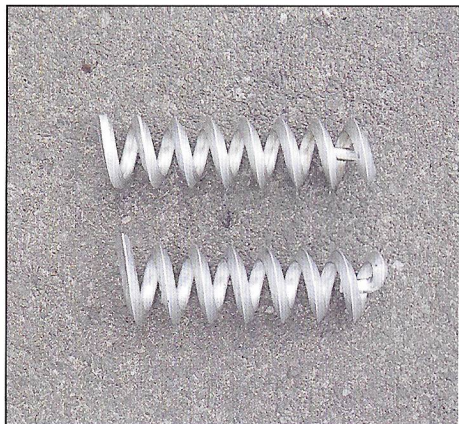
Vortok Coils.

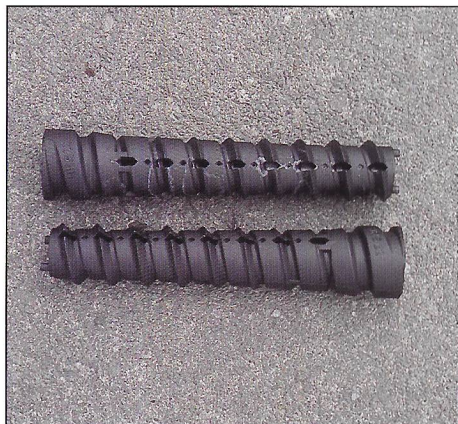
Hilti Rehabilitation sleeves.
